INVENTORY FORM FOR STATE HISTORIC SITES SURVEY

James K. Harper House
AND/OR COMMONDr. Franks' Residence**2 LOCATION**

303 North Commerce Street

QA-143

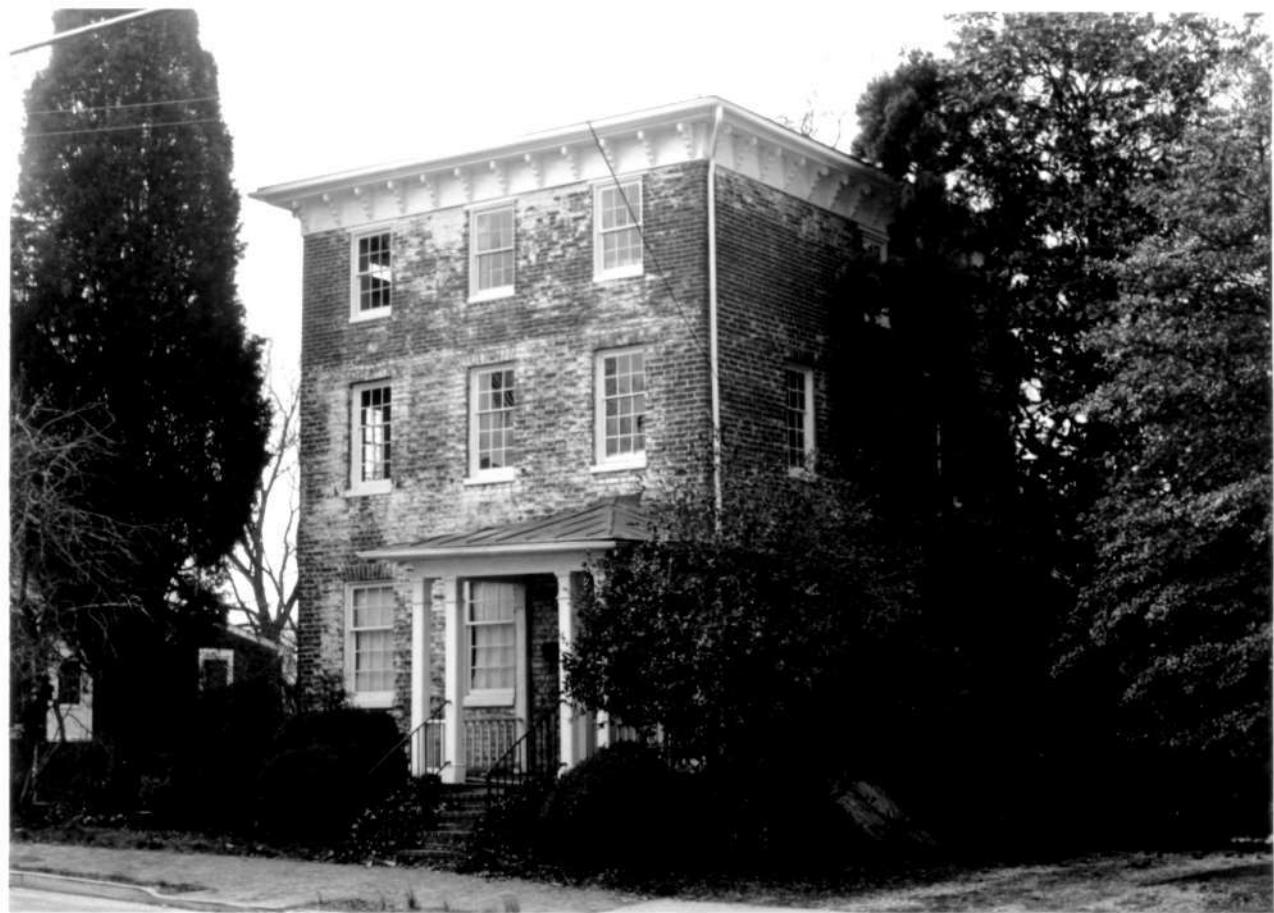
QA-143

Dr. Franks Residence
303 North Commerce Street
Centreville, Maryland
Orlando Ridout 1981
Front facade from Northeast

The front facade faces east to Commerce Street. The front entrance is in the north bay on the first floor, fitted with a 6-panel door and trimmed out with a five-light transom, paneled soffit and jambs, and a granite sill. There are two 6/9 windows to the left of the door, three 6/9 windows on the second floor, and three 6/6 windows on the later third story. Two cellar windows pierce the

The brickwork on the front facade is laid in Flemish bond above a three-course bond foundation. The window openings have splayed jack arch lintels one brick high. On the first floor the window openings have been enlarged approximately two inches on each jamb. The brickwork of the original building is quite similar to that found on other brick dwellings constructed in the first two decades of Centreville's existence. The bricks are somewhat larger than usual, and the coursing is very precise, bearing comparison in particular to two houses constructed on South Commerce Street in the mid-1790's (see QA-150 and QA-151).

The added third story is also brick, laid in six-course bond with smaller, machine-made bricks. The eaves are trimmed in with scrolled brackets applied to a plain frieze board below a box cornice with a deep soffit.

An entrance porch with square, chamfered posts and a standing seam hip roof protects the front door.

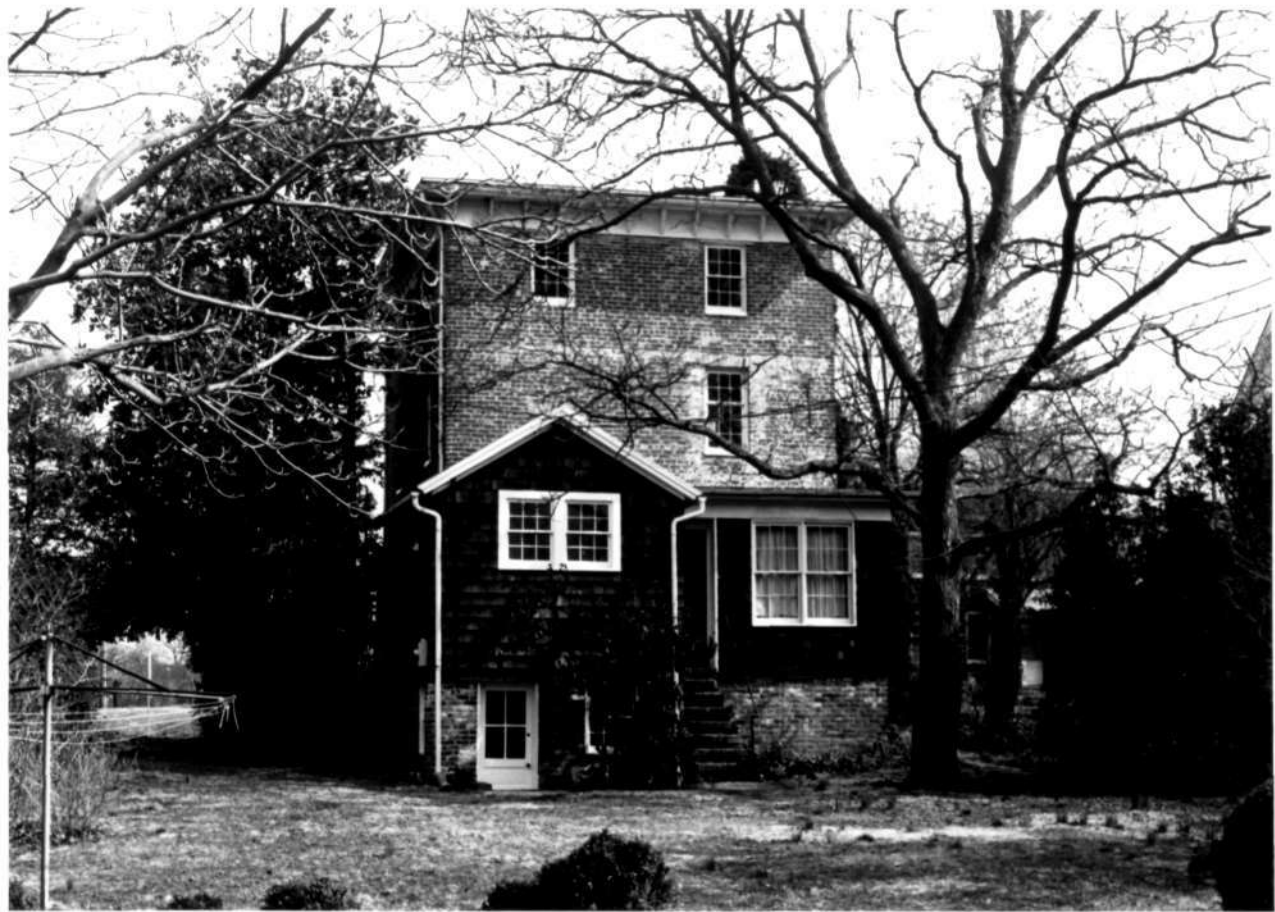
QA-143

Dr. Franks Residence
303 North Commerce Street
Centreville, Maryland
Orlando Ridout V 1981
Rear facade from West

A one story frame addition covers the first floor of the rear facade. The original rear door and two 6/9 windows remain in place on the first floor, but now open into the rear wing. On the second story, the north window is down-set over the stair landing, and has been reduced to a single six-light opening due to the roof of the later wing. The original 6/9 window remains intact in the south bay. There are two 6/6 windows on the later third story.

The original brickwork is laid in five-course bond. On the third story, early bricks from the demolished upper gable of the north wall have been reused to within six courses of the eave. Above that point machine-made brick is laid in common bond. The bracketed cornice is carried across the rear facade.
